**Flood Control Project Maintenance
Levee Inspections****LMA District Cover Sheet****Spring 2013 Levee Inspection Results****Yolo County Planning Resources and Public Works**

Spring 2013 Levee Inspection Results

Waterway			Bank	Unit Miles
Unit No. 01 Right Bank Cache Creek			Right	0.29
	Spring (March - May)	Summer (June - August)	(September - November) Fall	Winter (December - February)
Unit Maintenance Rating (Fall Only)				
Date of Inspection	-			
DWR Inspector	John Williamson			
Accompanied By

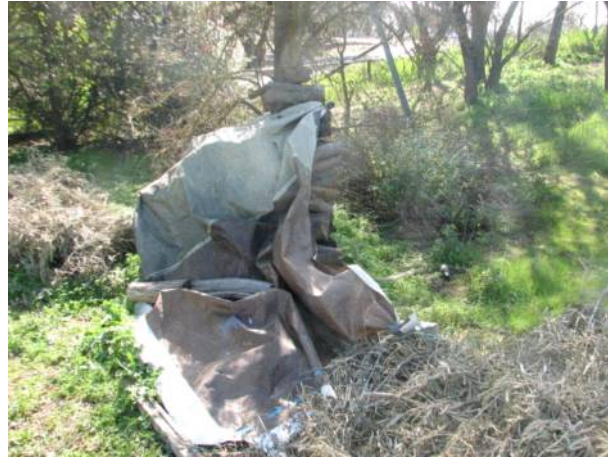
Levee Mile Report Line	4
Start Levee Mile	0.00
End Levee Mile	0.00
Location	Water Side
Category	
Item	Encroachments
The firewood has been shrinking in size. Spring 2013	
johngw_s_20130306_792.JPG

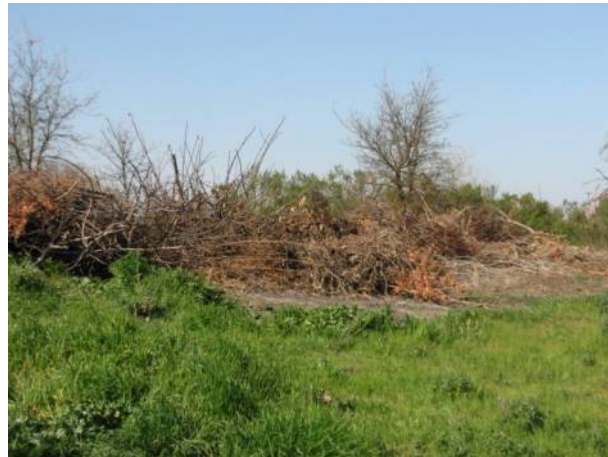
Levee Mile Report Line	5
Start Levee Mile	0.01
End Levee Mile	0.01
Location	Water Side
Category	
Item	Encroachments
A continuous brush pile on levee. Spring 2013	
johngw_s_20130306_793.JPG

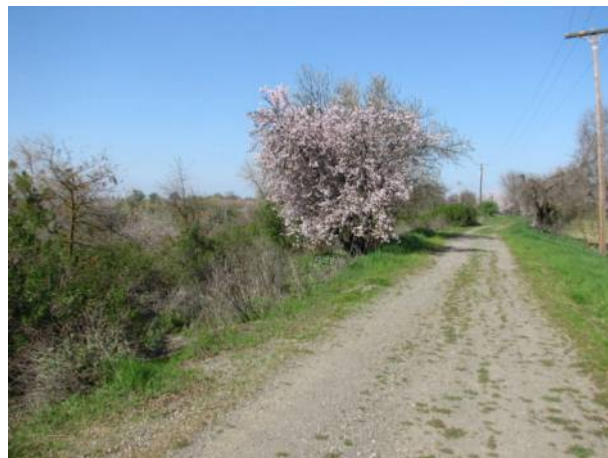
Levee Mile Report Line	6
Start Levee Mile	0.01
End Levee Mile	0.26
Location	Water Side
Category	
Item	Vegetation
Vegetation and brush is taller than 12 inches. No visibility of the waterside berm. Spring 2013	
johngw_s_20130306_794.JPG

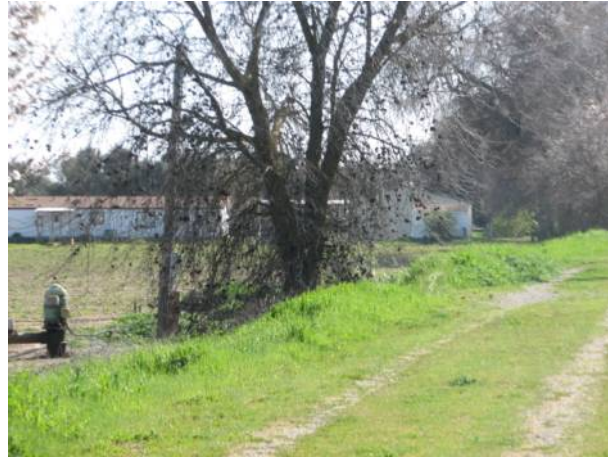
Levee Mile Report Line	10
Start Levee Mile	0.13
End Levee Mile	0.13
Location	Land Side
Category	
Item	Trim / Thin Trees
Tree needs to be trimmed up 5'. Spring 2013	
johngw_s_20130306_796.JPG

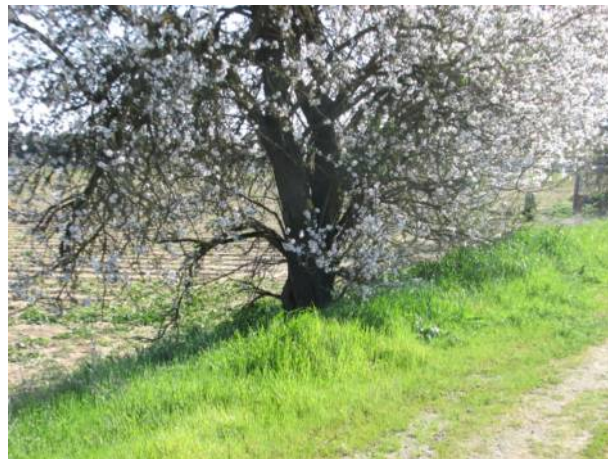
Levee Mile Report Line	11
Start Levee Mile	0.15
End Levee Mile	0.15
Location	Land Side
Category	
Item	Trim / Thin Trees
Tree needs to be trimmed to 5'. Spring 2013	
johngw_s_20130306_797.JPG

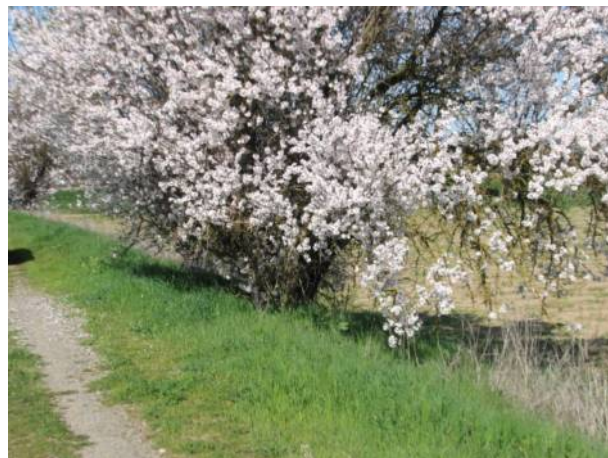
Levee Mile Report Line	12
Start Levee Mile	0.17
End Levee Mile	0.17
Location	Land Side
Category	
Item	Trim / Thin Trees
Trees need to be trimmed to 5'. Spring 2013	
johngw_s_20130306_798.JPG

DWR ID: DWR_NA0021_01_s_2012_7										
12	0.17	0.17		Trim / Thin Trees	LS	M Ma	T1 : Trim trees to at least five feet above ground level.	38.724445 ° -121.806505 °	38.724445 ° -121.806505 °	8 Y
DWR ID: DWR_NA0021_01_s_2012_8										
13	0.21	0.21		Trim / Thin Trees	LS	M Ma	T1 : Trim trees to at least five feet above ground level.	38.725022 ° -121.806478 °	38.725022 ° -121.806478 °	9 Y
DWR ID: DWR_NA0021_01_s_2012_9										
14	0.24	0.24		Trim / Thin Trees	LS	M Ma	T1 : Trim trees to at least five feet above ground level.	38.725427 ° -121.806470 °	38.725427 ° -121.806470 °	10 Y
DWR ID: DWR_NA0021_01_s_2012_10

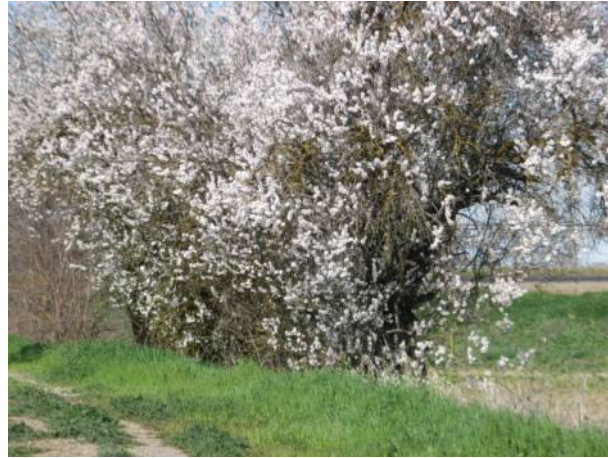
Levee Mile Report Line	13
Start Levee Mile	0.21
End Levee Mile	0.21
Location	Land Side
Category	
Item	Trim / Thin Trees

Trees need to be trimmed to 5'. Spring 2013

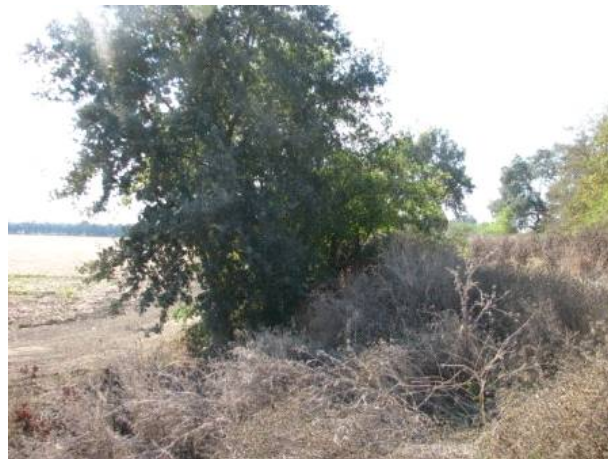
Levee Mile Report Line	14
Start Levee Mile	0.24
End Levee Mile	0.24
Location	Land Side
Category	
Item	Trim / Thin Trees

The tree needs to be trimmed up. Photo taken fall of 2011.
